AFFDL-TR-78-95

LIGHTNING STRIKE SUSCEPTIBILITY TESTS ON THE AIM-9 MISSILE

AUGUST 1978

TECHNICAL REPORT AFFDL-TR-78-95
Final Report for Period October 1977 – November 1977

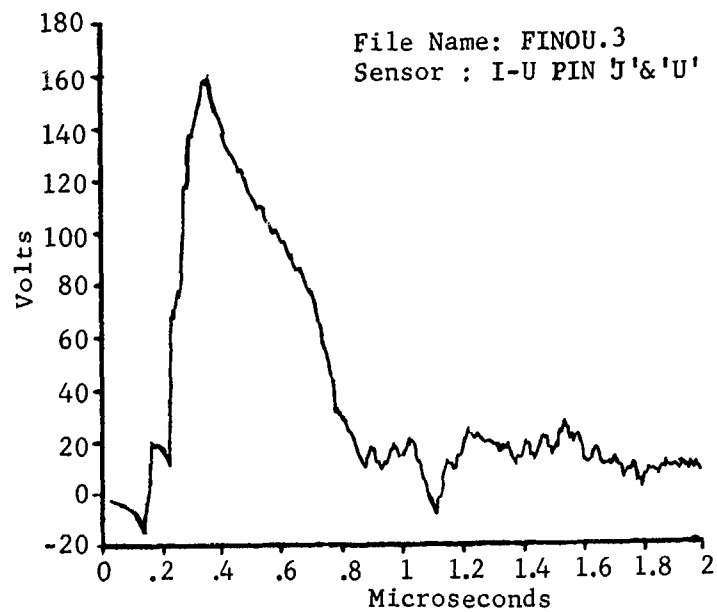
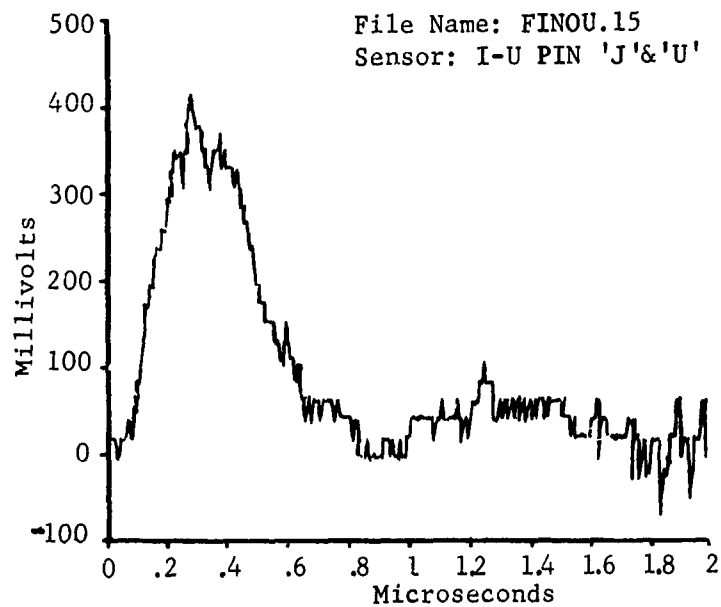
Figure 6. Comparison of Induced Voltages on Conductors J - V
With and Without Shielding on Umbilical Cable

The initial induced voltage measurements were made on the umbilical cable without shielding. Subsequently it was realized that the umbilical cable is shielded by the pylon in a normal aircraft installation. The setup was modified by shielding the cable with aluminum and the measurements repeated. Significantly lower voltage readings were obtained. From this it was speculated that the higher voltage readings were the result of voltages induced on the unshielded cable by the time-varying electromagnetic field rather than by the skin currents on the missile surface, and that the voltage induced by the skin current would be low as indicated by the second set of measurements.

The addition of the foil drastically reduces the electrical field or E-field coupling on the circuitry. However, the addition of the foil also creates a path for the simulated lightning current to flow in close proximity to the unshielded conductors within the umbilical, so that the influence of the magnetic field or H-field created by this current increases. What effect this increase would have on the circuitry is not known since insufficient induced current measurements were made on the cable circuits.

Figure 6 is a comparison of the induced voltage magnitude and waveshape measured on conductors J-V. The large reduction in voltage magnitude (volts to millivolts) due to the addition of foil shielding around the umbilical cable is evident.

Since the induced transients measured on the missile umbilical could have significant effects on missile performance, the organization having primary responsibility for the AIM-9 missiles should determine the possible impacts and needs for further tests or corrective measures.
